# Characterizing the Middle Yegua, Davidson Creek and Deer Creek Watersheds Final Report

Prepared for the Texas State Soil and Water Conservation Board

**TSSWCB Project #18-52**

Appendix L: Middle Yegua, Davidson, and Deer Creek Characterization Report .....	54

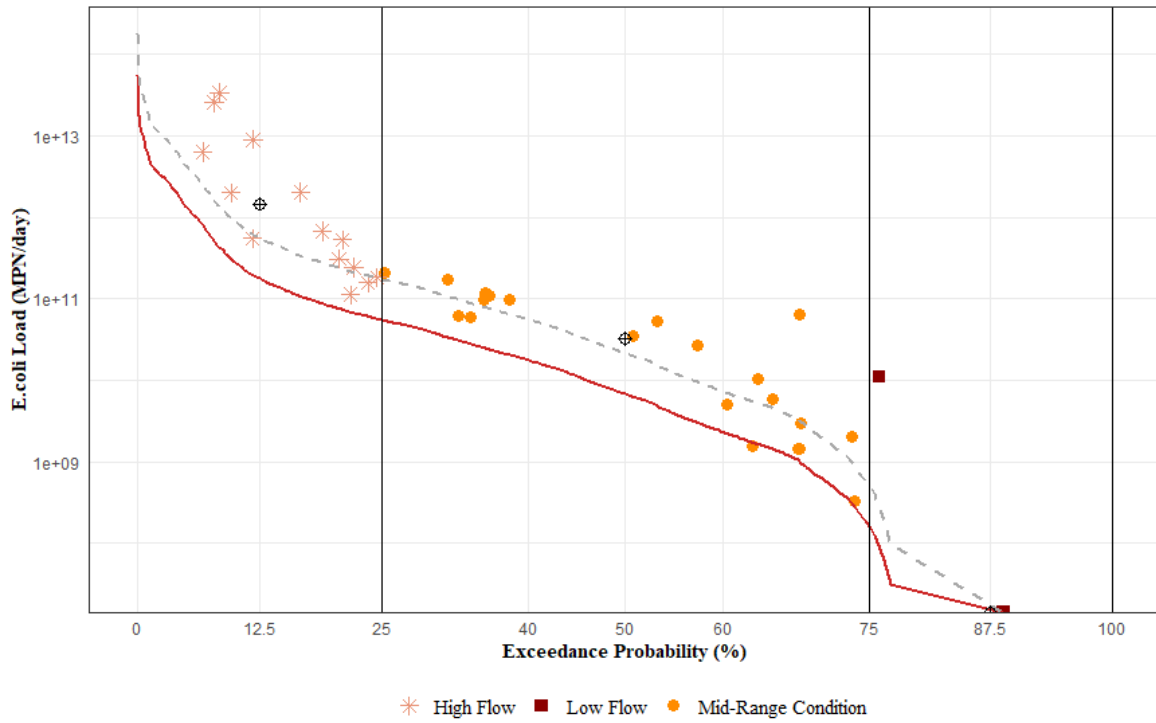
Figure 57. Load duration curve for Davidson Creek SWQM stations 11729, 18349, and 21420. The solid red line indicates the allowable load at geomean criterion (126 MPN/100mL) and the gray dashed line is allowable load at single sample criterion (399 MPN/100mL). The black circles indicate the existing geomean load in each flow regime (MPN/day)

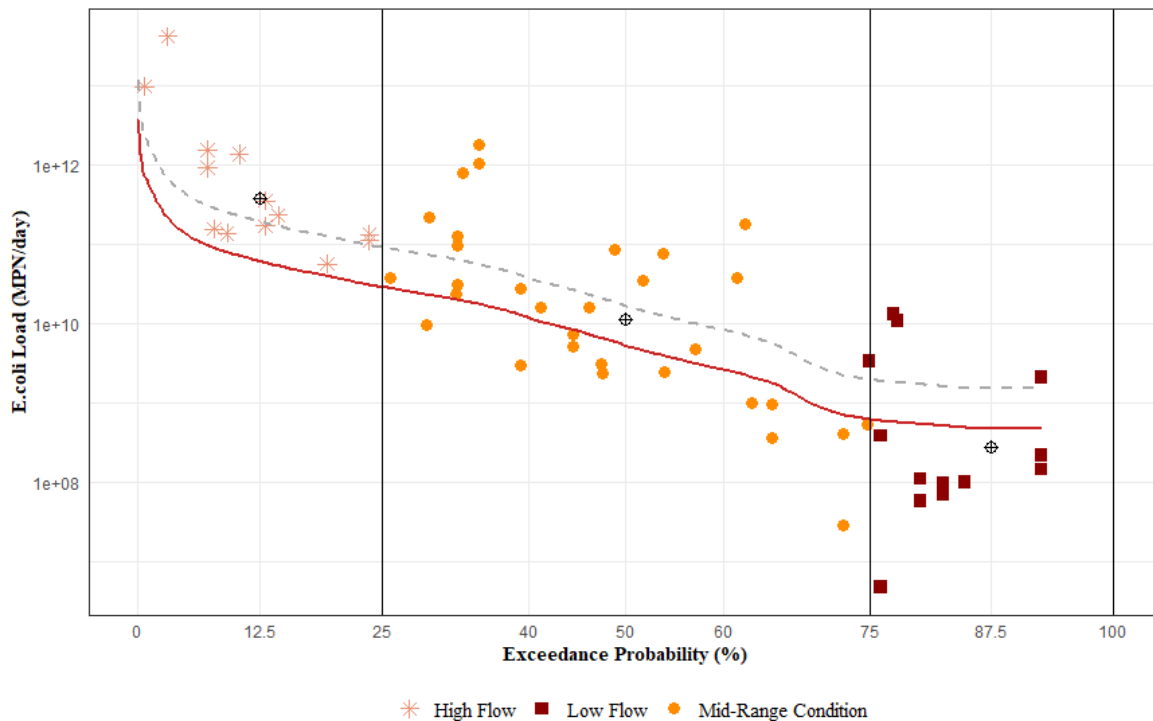
Figure 58. Load duration curve for Deer Creek SWQM stations 11723 and 18644. The solid red line indicates the allowable load at geomean criterion (126 MPN/100mL) and the gray dashed line is allowable load at single sample criterion (399 MPN/100mL). The black circles indicate the existing geomean load in each flow regime (MPN/day)

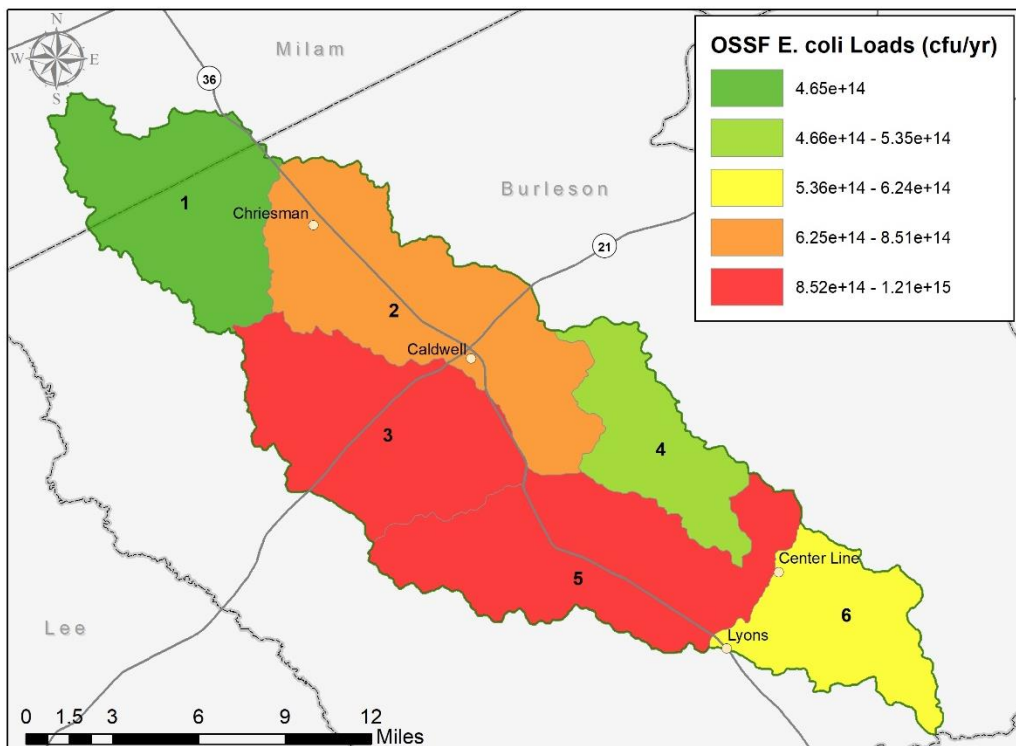
Figure 81. Potential annual bacteria loadings from OSSFs in the Davidson Creek watershed

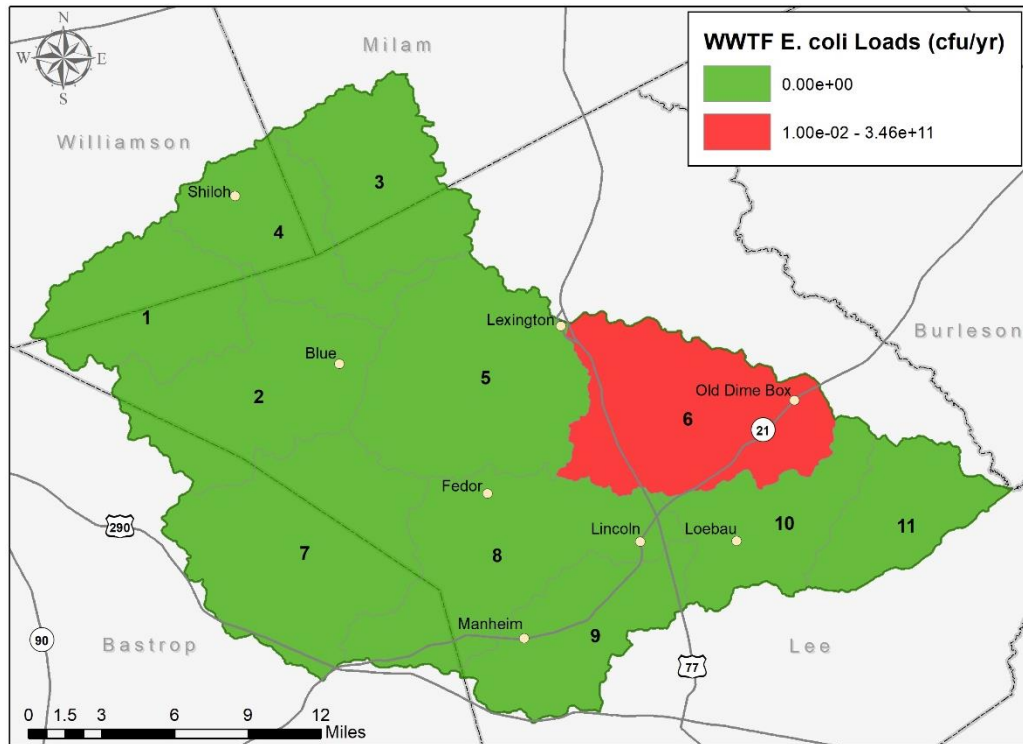
Figure 86. Potential annual bacteria loadings from WWTFs in the Middle Yegua Creek watershed

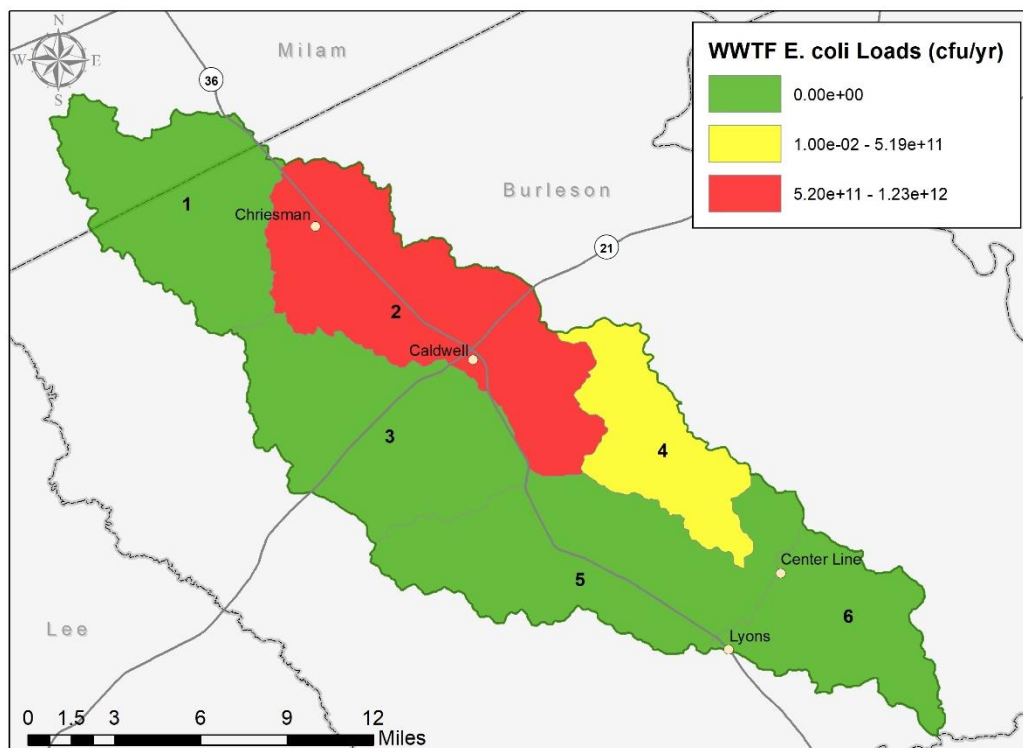
Figure 87. Potential annual bacteria loadings from WWTFs in the Davidson Creek watershed
